PROJECT : SPACE TAFT
 LOCATION : 1952 TAFT AVE., MALATE , MANILA
 OWNER/DEVELOPER : PACIFIC AVELEX REALTY CORP.
 SUBJECT : PROGRESS REPORT
 DATE : 9-May-17

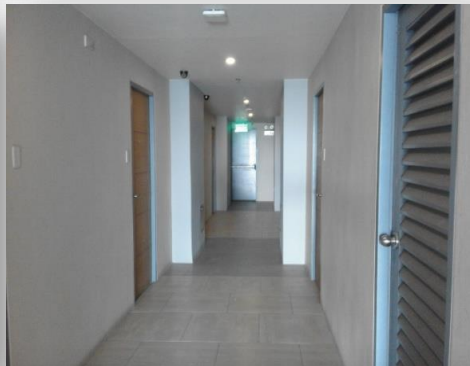
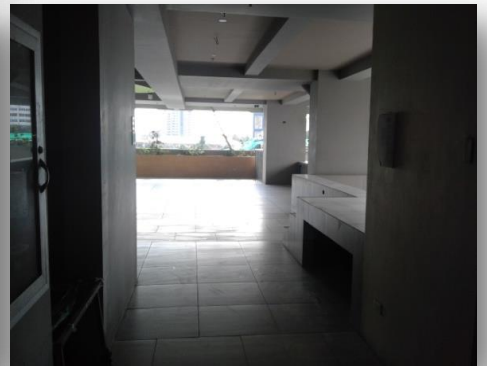
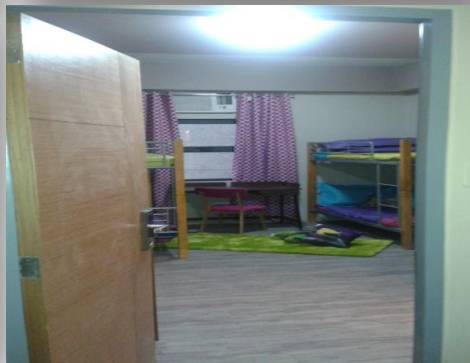
4F : Model units and amenities

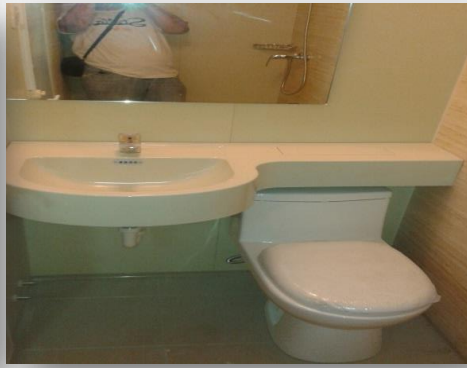
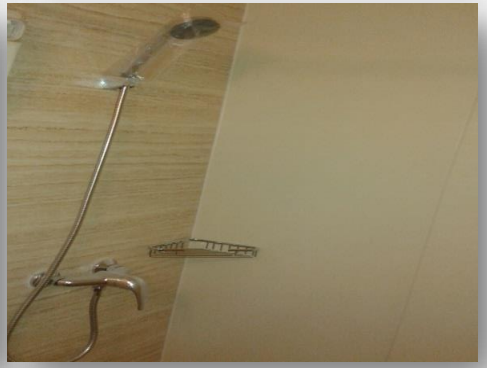
- ➡ Installed up to 28th floor; and assembled at 29th floor

Modular Toilets

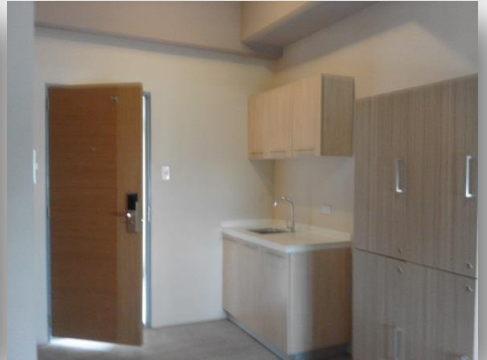
- ➡ Installed up to 21st floor

Kitchenette

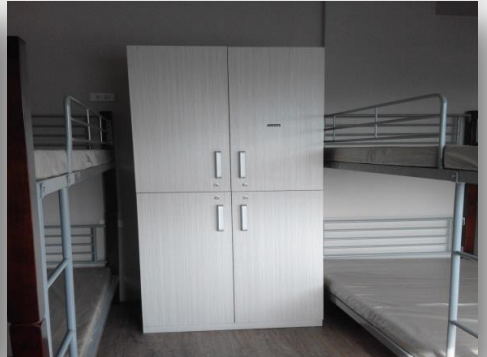
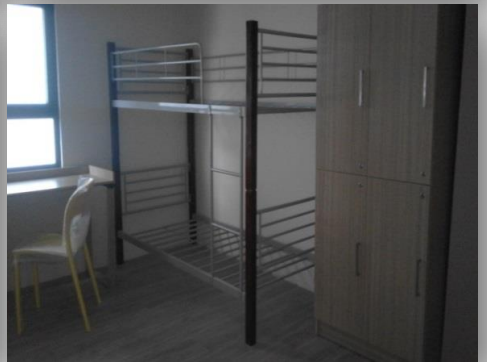
- ➡ Installed up to 14th floor

Furnitures: Bunkbeds, closet and desk

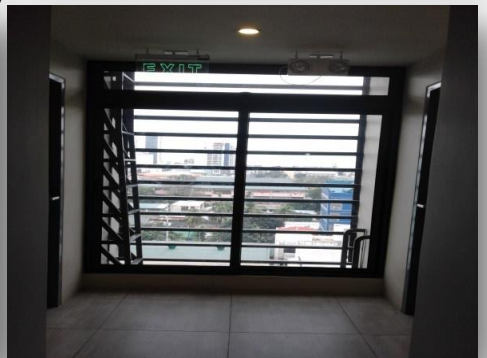
Sliding Glass Door at hallway and Monkey Ladder(front elevation emergency exit)-additional

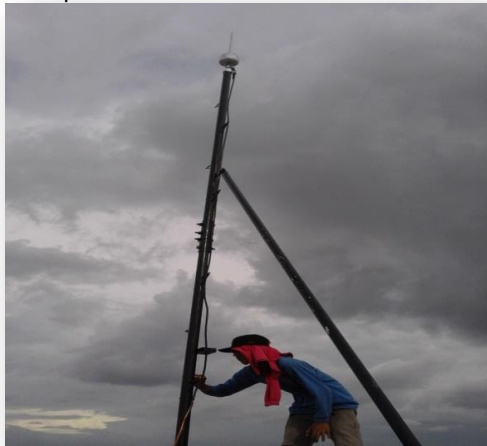
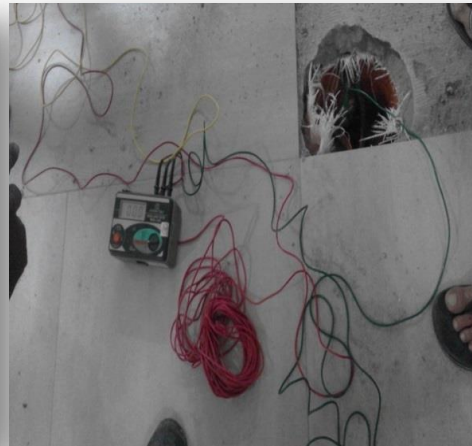
LIGHTNING ARRESTER

Completed and Tested

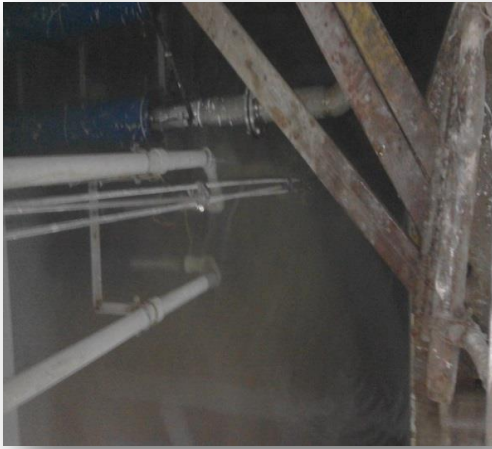
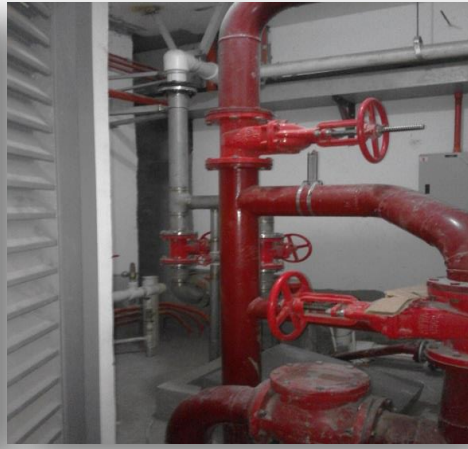
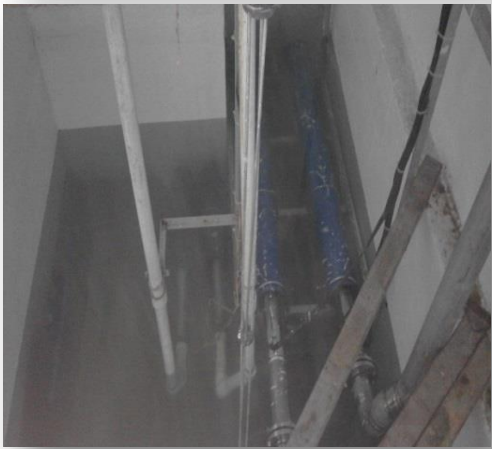
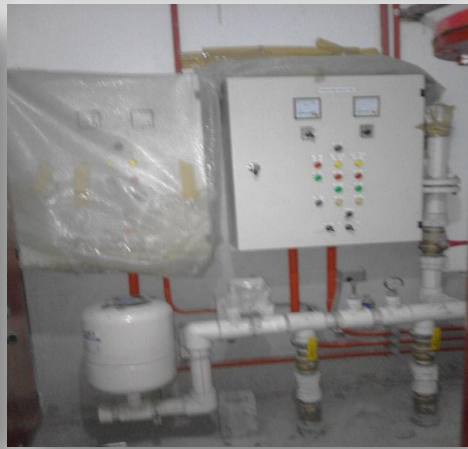
CISTERN TANK AND FIRE TANK

- 1 Submersible Transfer Pump
- 2 Submersible Booster Pump
- 3 Fire Pump
- 4 Jockey Pump

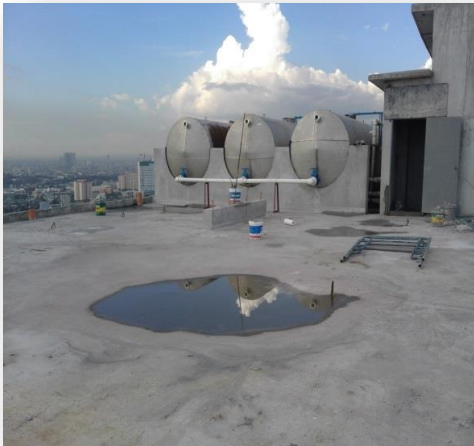
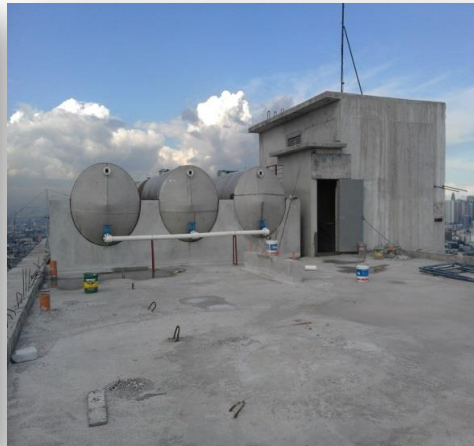
ELEVATED TANK

3 UNITS -installed

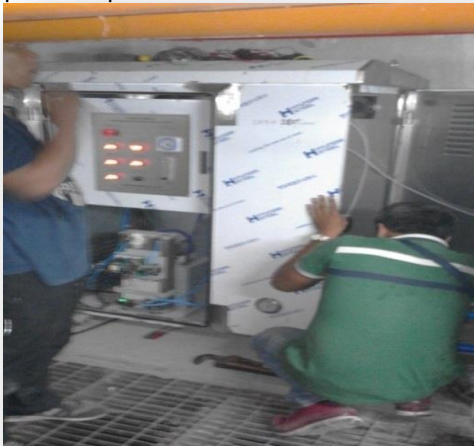
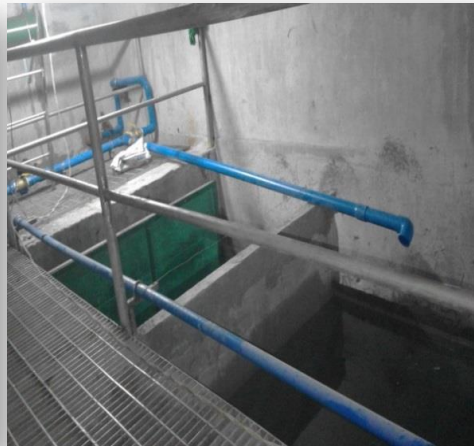
STP

Completed-Operational

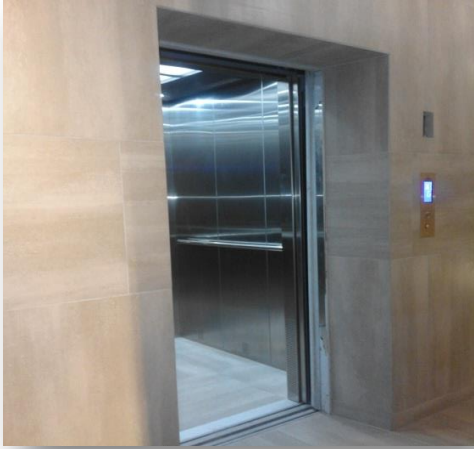
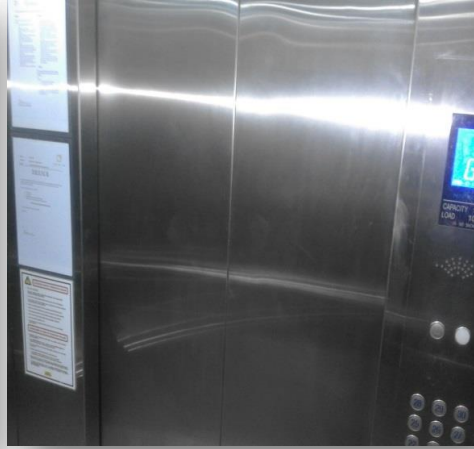
Installation of ELEVATOR

98%Completed-remaining installation of hallbuttons
