PROJECT : SPACE TAFT
 LOCATION : 1952 TAFT AVE., MALATE , MANILA
 OWNER/DEVELOPER : PACIFIC AVELEX REALTY CORP.
 SUBJECT : PROGRESS REPORT
 DATE : 9-May-17

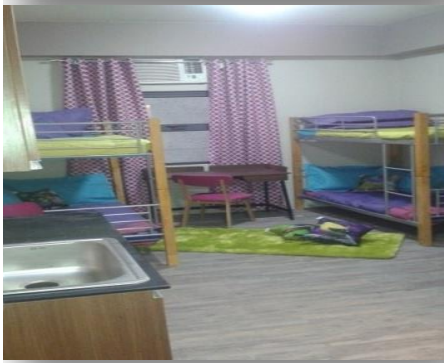
4F : Model units and amenities

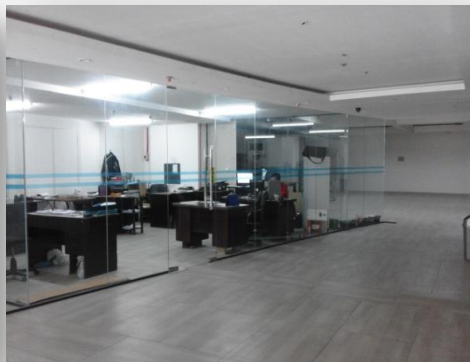
MF: Commercial units

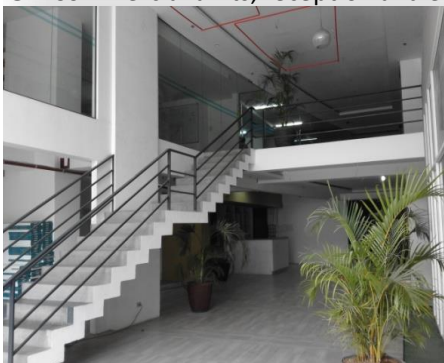
GF: Commercial units, reception and elevator lobby.

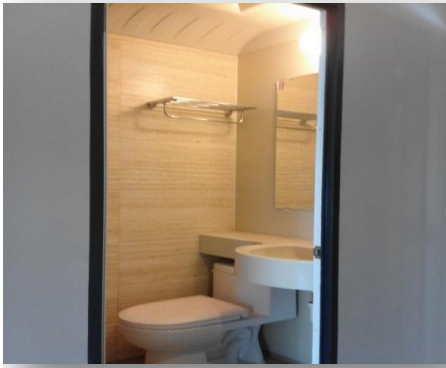
Modular Toilets

- ➡ Installed up to 28th floor; and assembled at 29th floor

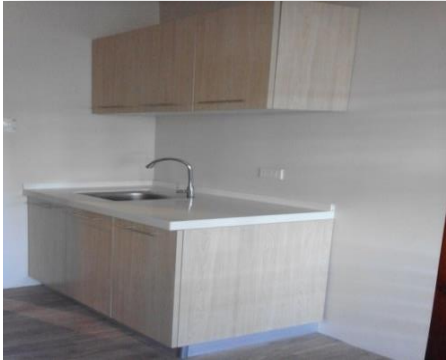
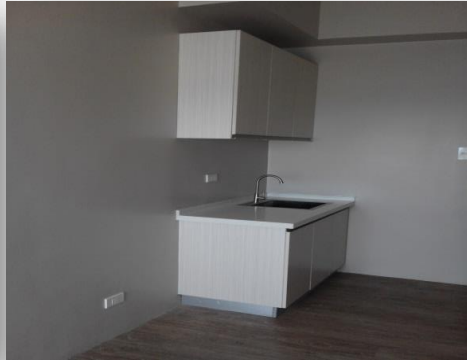
Kitchenette

- ➡ Installed up to 21st floor

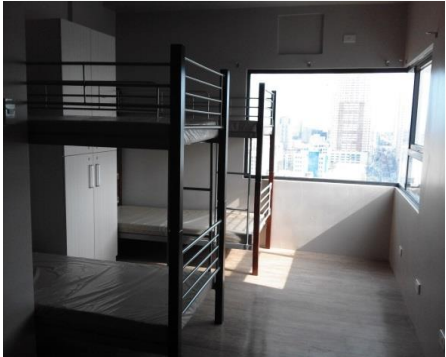
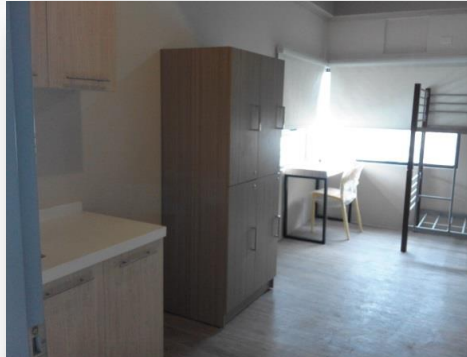
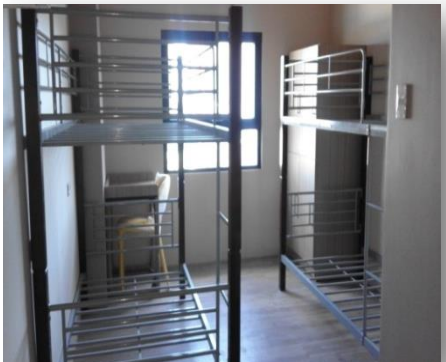
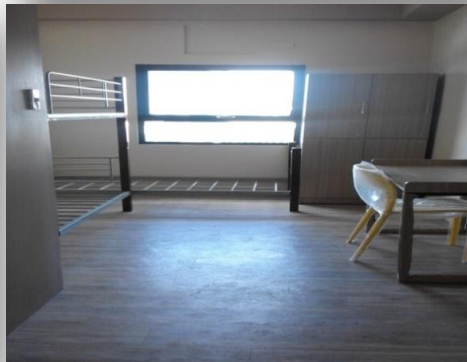
Furnitures: Bunkbeds, closet and desk

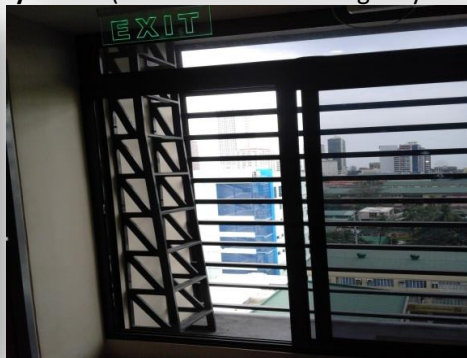
Sliding Glass Door at hallway and Monkey Ladder(front elevation emergency exit)-additional
